## Good Shepherd Center Replanting Proposal

Date: 11/3/2020  
To: Landmarks Preservation Board  
From: Tara Macdonald, Lead Gardener for Historic Seattle, PDA – Good Shepherd Center  
Subject: Hazard tree replacement proposal for Good Shepherd Center  
Address: 4649 Sunnyside Ave N, Seattle, WA 98103  
Parcel #: 0825049102

## Arborist Report

**Date:** 6-5-2020  
**To:** Tara Macdonald, Lead Gardner - Good Shepard Center  
**From:** Nicholas Johnson, OOC Arborist – Seattle Parks and Recreation  
**Subject:** Tree Assessment and Hazard Evaluation

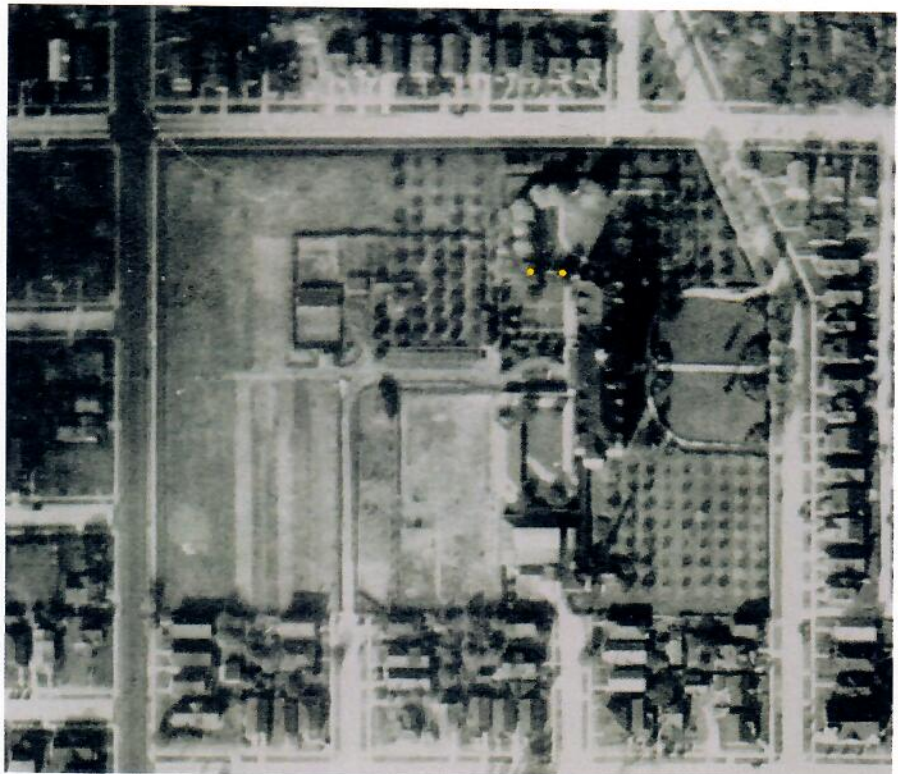
The two horse chestnuts to be removed were probably planted before 1929. The photo is not of great quality, but one can make out trees in the same locations (designated by yellow dots) as the existing horse chestnuts and assume they are the same trees. There is no apparent change in subsequent aerial photos. We know of no other photos or records of these trees before the mid-1970s. The trees are to the west of the main building creating a line between an apparent formal garden to the south of them and a lawn area surrounded by a horseshoe arrangement of trees to the north of the building. In 1953 an addition, now called the North Annex, was built in the lawn area along with a garage

and driveway on the north side of the horse chestnuts. The garage and driveway were built on top of the roots of the horse chestnuts. Those 2 buildings broke up the spatial relationship that existed previously that may have been defined in part by the horse chestnuts, therefore the removal of the trees will not significantly change the spatial relationships of the surrounding area as they have existed since 1953.

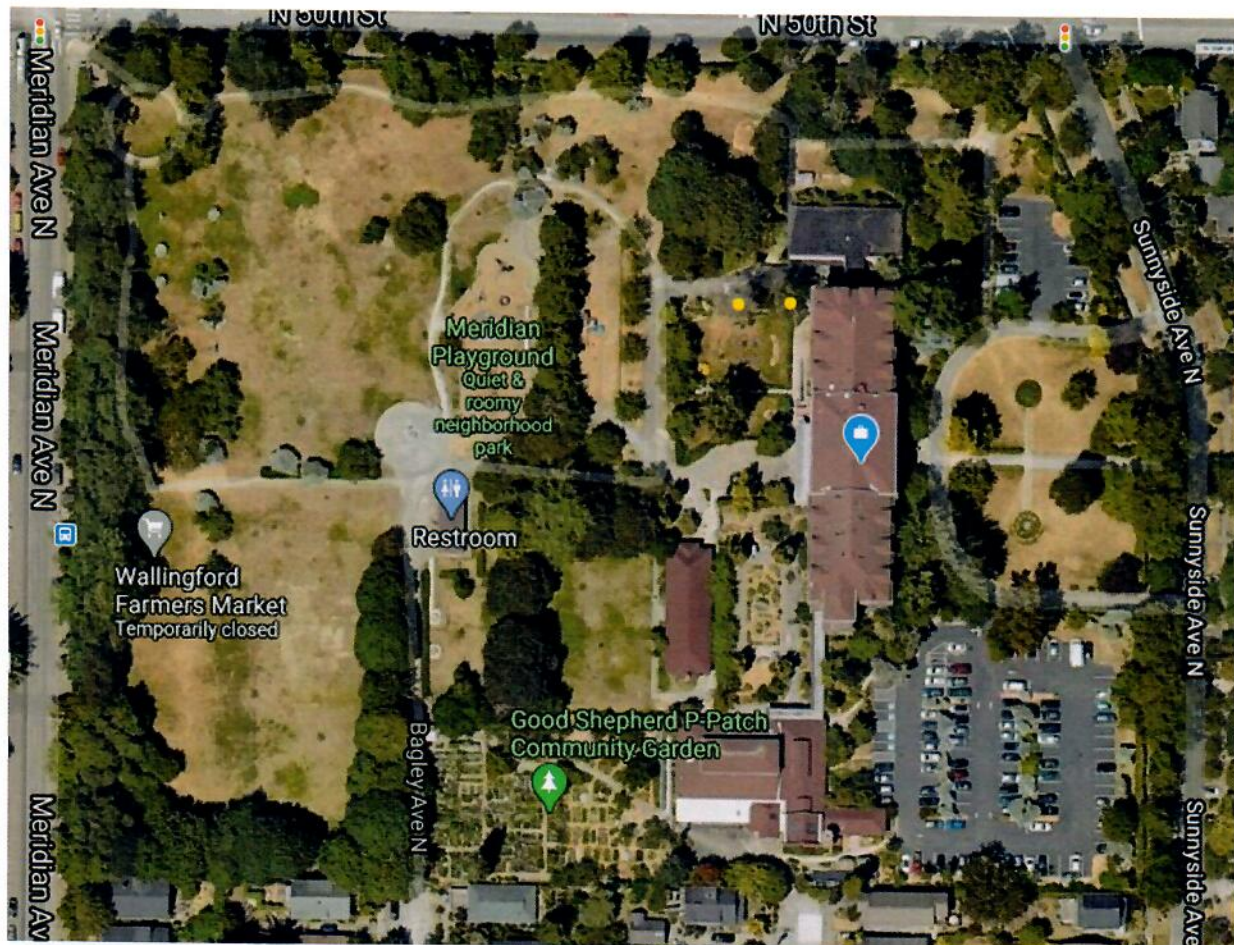
This 2018 aerial photo shows how the buildings and drive now break up the space that these trees once helped define. Since 1953 the trees have simply been nice shade trees on the north edge of the formal garden.

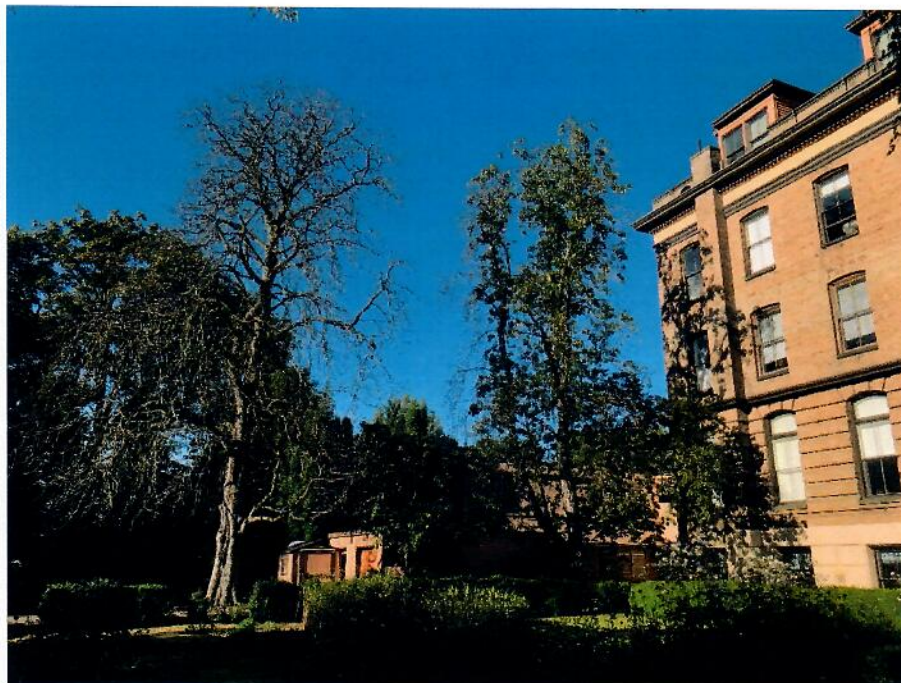
We would like to replace only one of these trees in the same approximate location. The tree on the left, TREE -23382, is in a reasonably good location for a replacement tree, but the one on the right, TREE-23383 is too close to both the sidewalk and the garage to replant in the same space.

Because the trees are being killed by fungi that will remain in the soil, it is inadvisable to replant with the same species. We propose planting a *Quercus garryana*, Oregon White Oak, instead of another horse chestnut in place of TREE-23382. *Quercus garryana* is comparable in size, shape, and character and is predicted to handle climate change well. Replacing TREE-23382 with an Oregon White Oak in the same location accounts for 1 of the 4 trees required.

Because of the space defining garage and drive and the very close proximity of TREE-23383 to the garage and sidewalk, this tree should not be replaced in kind or location. It is no longer an appropriate location to plant a large tree. Planting further away from both would interrupt the character of the adjacent formal garden. Planting beside the garage would risk limb drop onto the building. Instead we are proposing to plant elsewhere on the grounds with space for additional large trees.

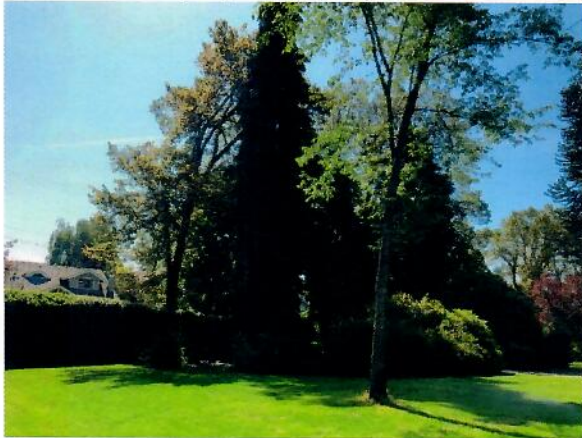
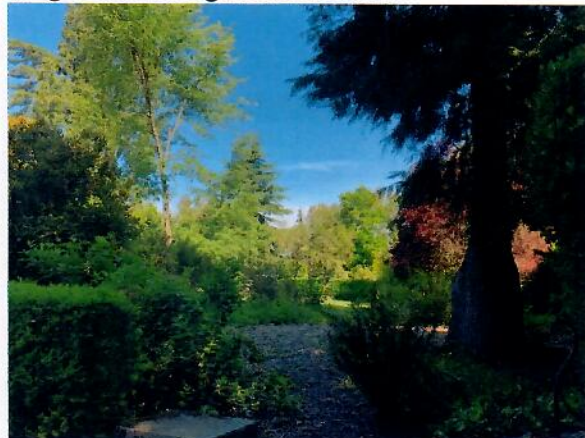
Bed to the north of the center pedestrian entrance where one *Calocedrus decurrens* and one *Acer circinatum* are proposed: Left photo is from the lawn, right from the gated entrance.

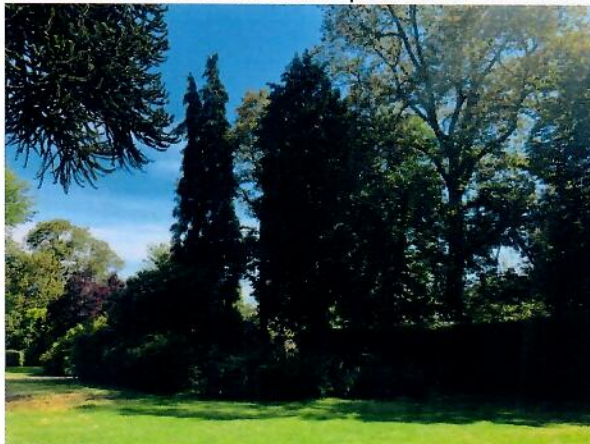
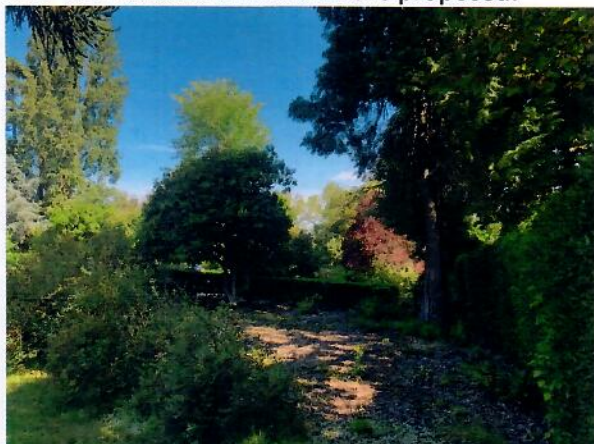
Bed on the south side of the pedestrian entrance where one *Calocedrus decurrens* is proposed:
